FLOOD PLAIN MANAGEMENT STUDY

CITY OF CHEWELAH

STEVENS COUNTY, WASHINGTON

SOIL CONSERVATION SERVICE
U.S. DEPARTMENT OF AGRICULTURE

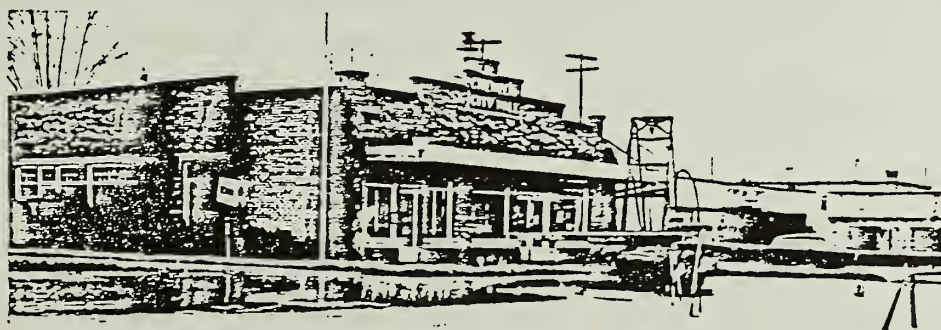
Photo showing flooding near city hall at the corner of Highway 395 and Webster Avenue.

"The January 24, 1974, edition of the paper indicates that early in the week heavy snows, followed by chinook winds caused flooding. The Wrights Valley road washed out and the water came up over 395 at City Hall and traveled down the adjacent streets. By January 23, the city park was entirely underwater and water was over the bridges on East Lincoln, Webster and 395. There was flooding at the intersections of Main Avenue and Second Street and at King and Second. Some flooding in basements was reported." /1.
